**Procedia
Engineering**www.elsevier.com/locate/procedia11th International Conference on Modern Building Materials, Structures and Techniques,
MBMST 2013

Influence of Amount and Arrangement of Reinforcement on the Mechanism of Destruction of the Corner Part of a Slab-Column Structure

The paper presents results of laboratory investigations concerning a nine field slab-column structure in the scale 1:2. As a model served a reinforced concrete slab with the dimensions of 9300×9300×100 mm. The aim of the investigations was to determine mechanism of destruction of the corner part of a slab-column structure caused by the removal of the support depending on the applied reinforcement. The paper contains the results of laboratory tests compared with the results of simplified numerical calculations.

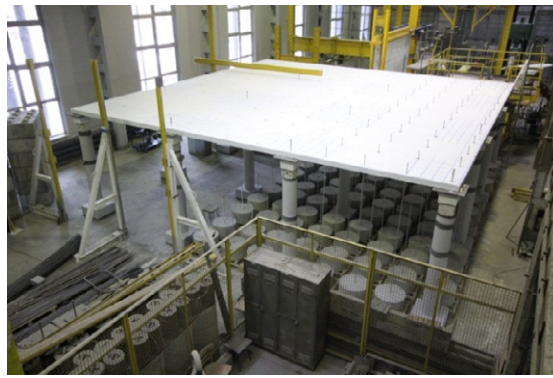
Fig. 1. View of the model and test stand

The test stand consisted of sixteen prefabricated supports with a height of 2400 mm, which were affirmed to the slab of the laboratory. On these supports the dynamometers for the measurement of reactions of support were imbedded in specially prepared clamping. In the place in which the loss of support was simulated, instead of a prefabricated reinforced concrete the hydraulic cylinder with a large extension was applied. During the investigations, both the model and the test stand were stiffened by steel braces. A view of this model and of the test stand is to be seen in Fig. 1.

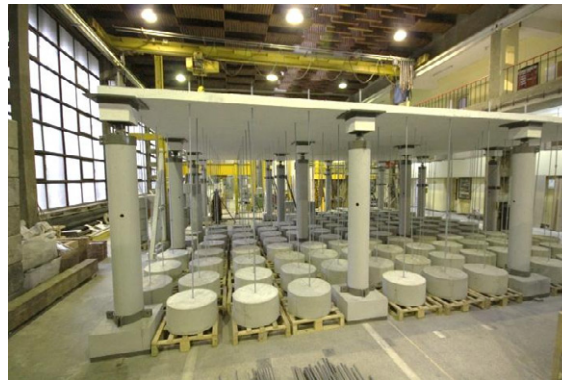
Fig. 6. System of gravitational load

- the system of gravitational load (the gravitational load F was realised by means of concrete weights with a mass of 200 kg suspended at 152 points), see Fig. 6;
- an external system of hydraulic load (the hydraulic load $H1$ consisted of a set of 12 hydraulic cylinders), see Fig. 5a;

In the first stage of investigations gravitation loads were suspended from the model at 132 points, consisting of concrete loads (Fig. 6). After each of suspended weight the value of the support reactions was read. Next, the vertical displacements of the upper surface of the respective models were measured. In the second stage to each model (Model 1 and Model 2) a preliminary load was imposed the values of which amounted to 2 kN for system H1 and 1 kN for system H2 (Fig. 5a). Next the reactions of the supports and the displacements of the upper surface of the given model were read off. In the third stage of investigations the corner support was lowered at the preset value of the load. The fourth stage consisted in a stepwise increasing of the value of the load ($H1/H2=2$) up to the moment of the complete destruction of the model, which occurred at a load of 9 kN in the case of Model 1 and 23 kN in the case of Model 2.
